FINAL REPORT  
AUGUST 1990

REPORT NO. EVT 15-90-1

MIL-STD-1660 TESTS  
OF  
VOLCANO PALLET  
AND  
PALLET ADAPTER

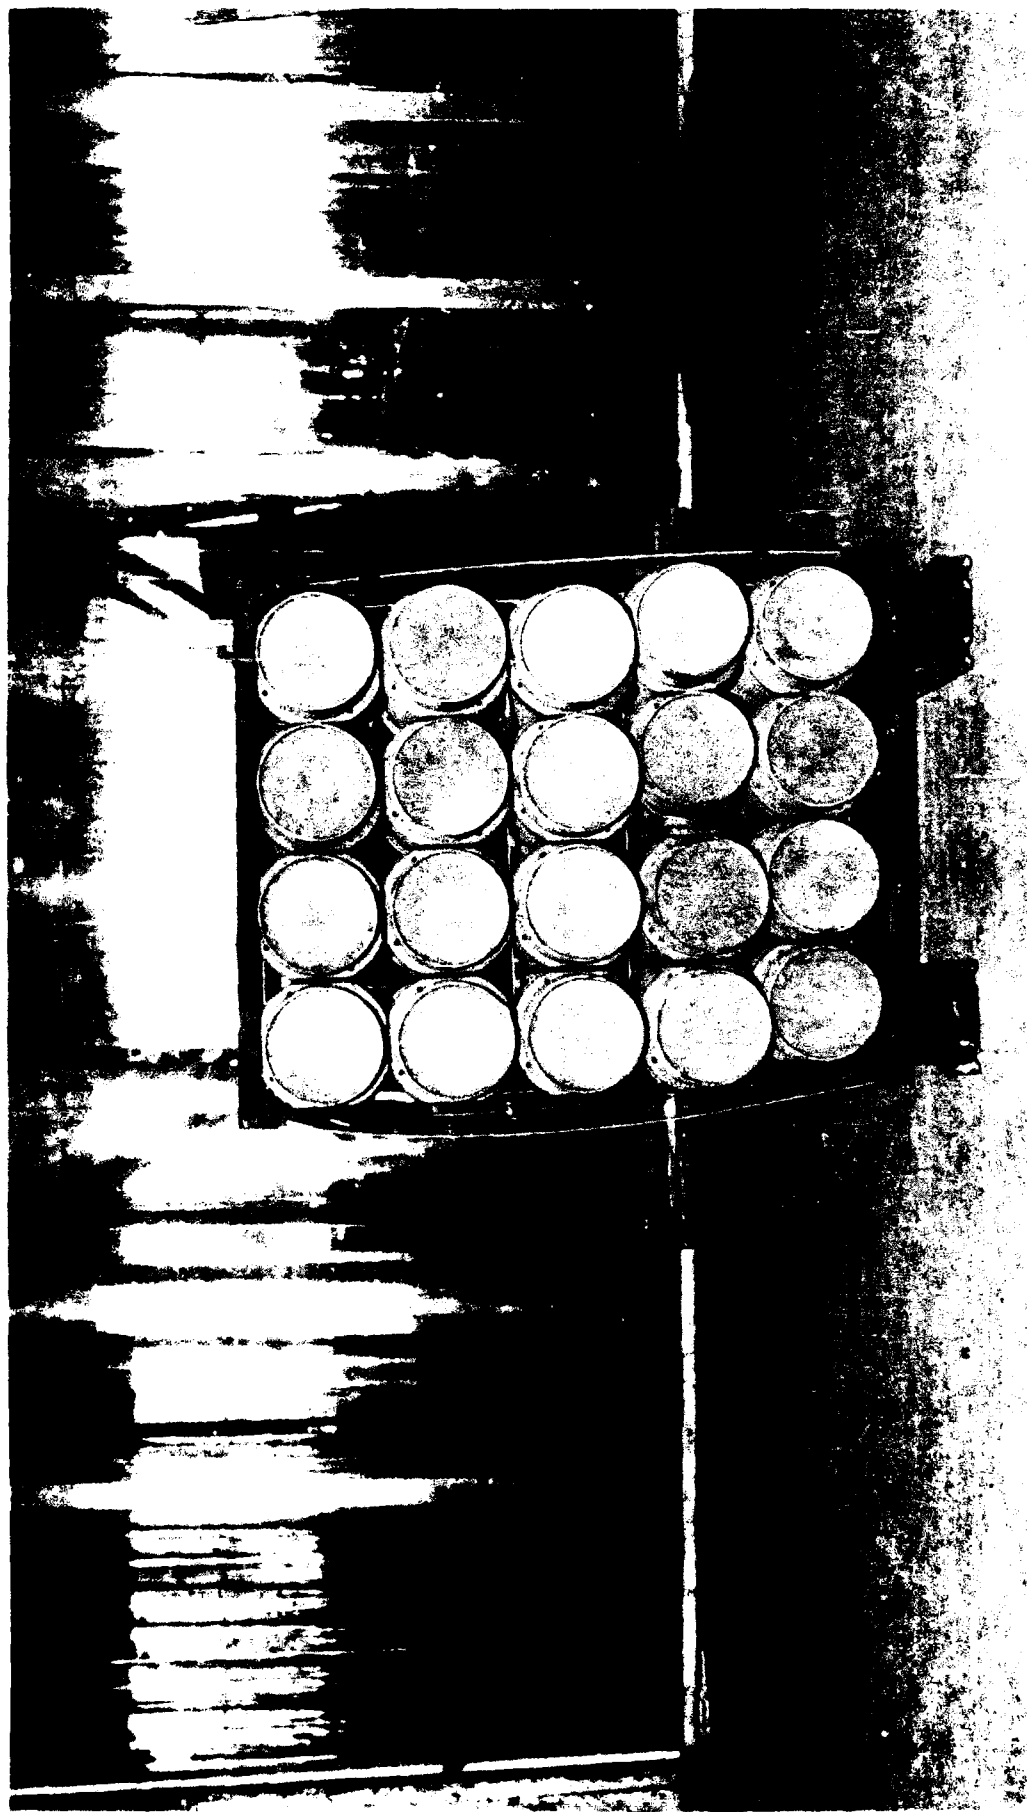
Photo No. AO317-SPN-90-354-5327. This photo shows the deformation of the unitized load following the first iteration of testing.

3. EDGEWISE ROTATIONAL DROP TEST. Each side of the pallet base was placed on a beam displacing it 4-1/2 inches above the floor. The first drop was the bell end of the pallet dropped from a height of 24 inches per MIL-STD-1660 specifications. This process was repeated in a clockwise direction until all four sides of the pallet had been tested. Since the pallet is susceptible to tipping, the sides were only dropped from 16 inches instead of 24 inches. The third drop, the base end, was dropped and because of the poor quality of the PA113 Volcano containers, four stacking pins on the bell end of the containers sheared off, causing the containers on three and a half layers to shift forward 2-1/2 inches. The problem was due to bent stacking ports, since some stacking lugs were not engaged in the containers above. The faulty containers were replaced and the remaining containers were repaired to continue on with testing.

1. CONCLUSIONS. The Volcano pallet and pallet adapter passed MIL-STD-1660 design criteria for ammunition unit loads. Except for the damage to the substandard containers in the first iteration of MIL-STD-1660, which allowed the containers to shift substantially, no problems occurred during subsequent testing.
2. RECOMMENDATION. Assure all PA113 containers are in good condition while unitizing. The stacking pins must engage in the upper container for safe palletization.

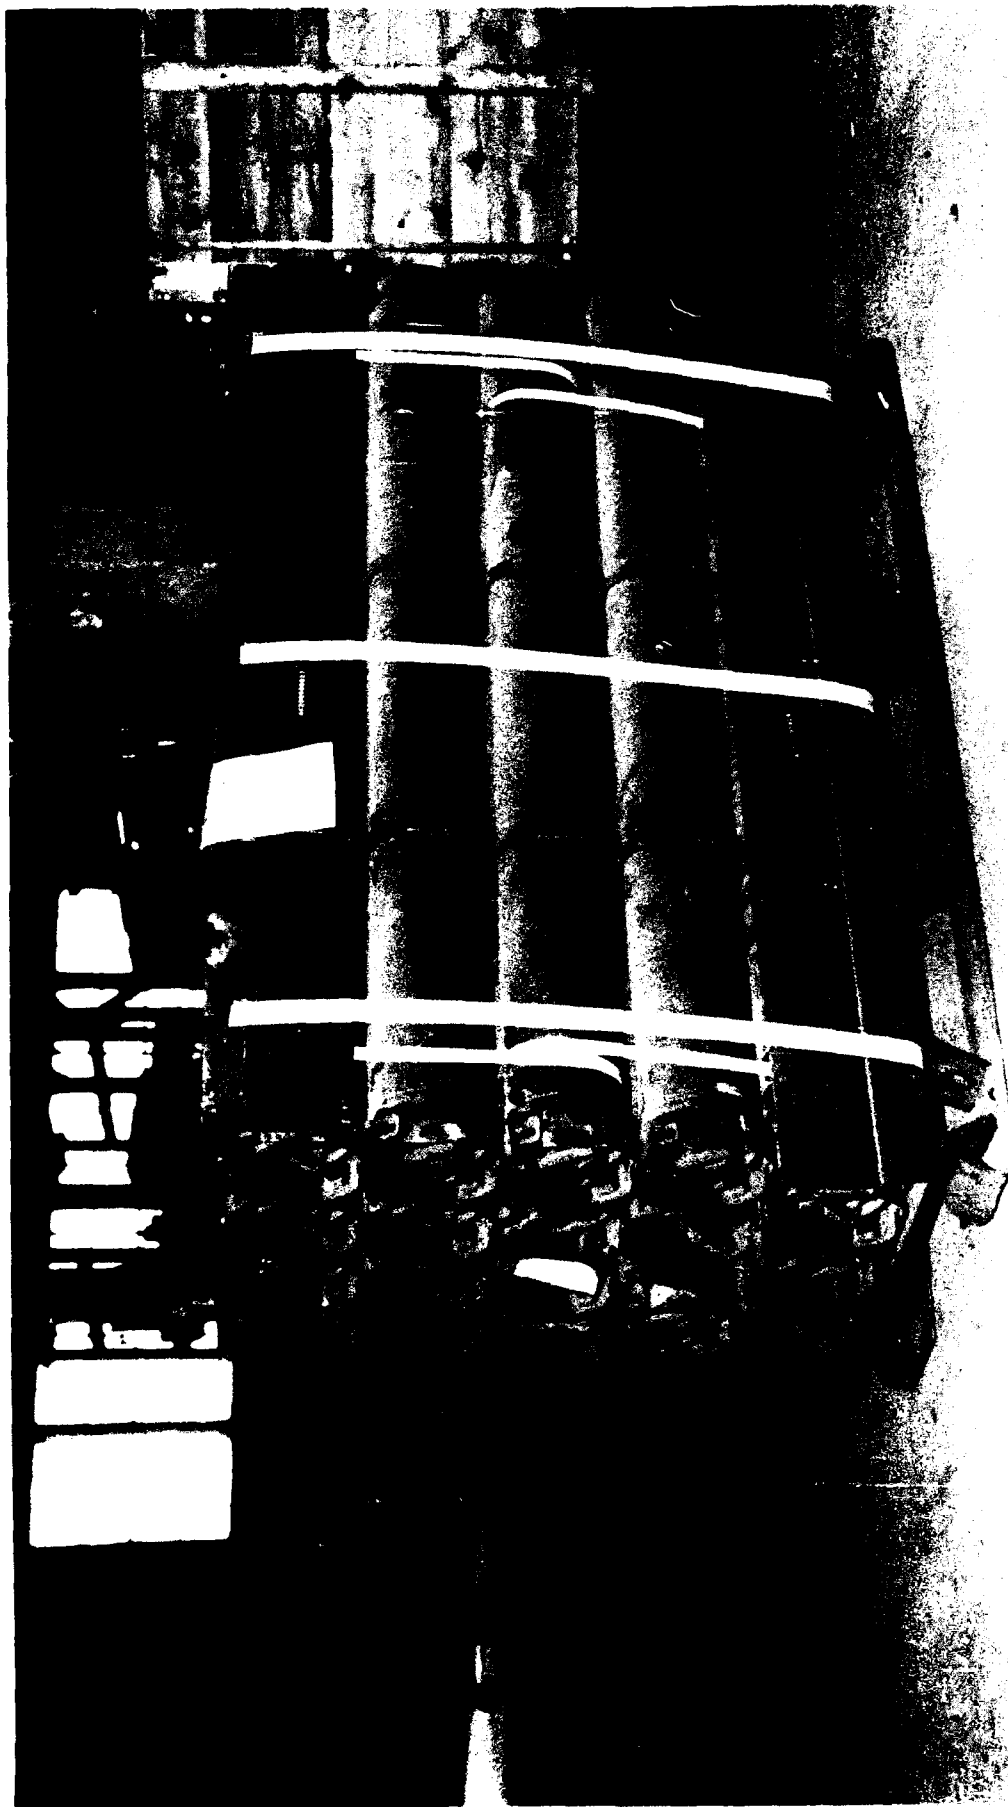
Photo No. AO317-SPN-90-354-5326. This photo shows the deformation of the unitized load following the first iteration of testing

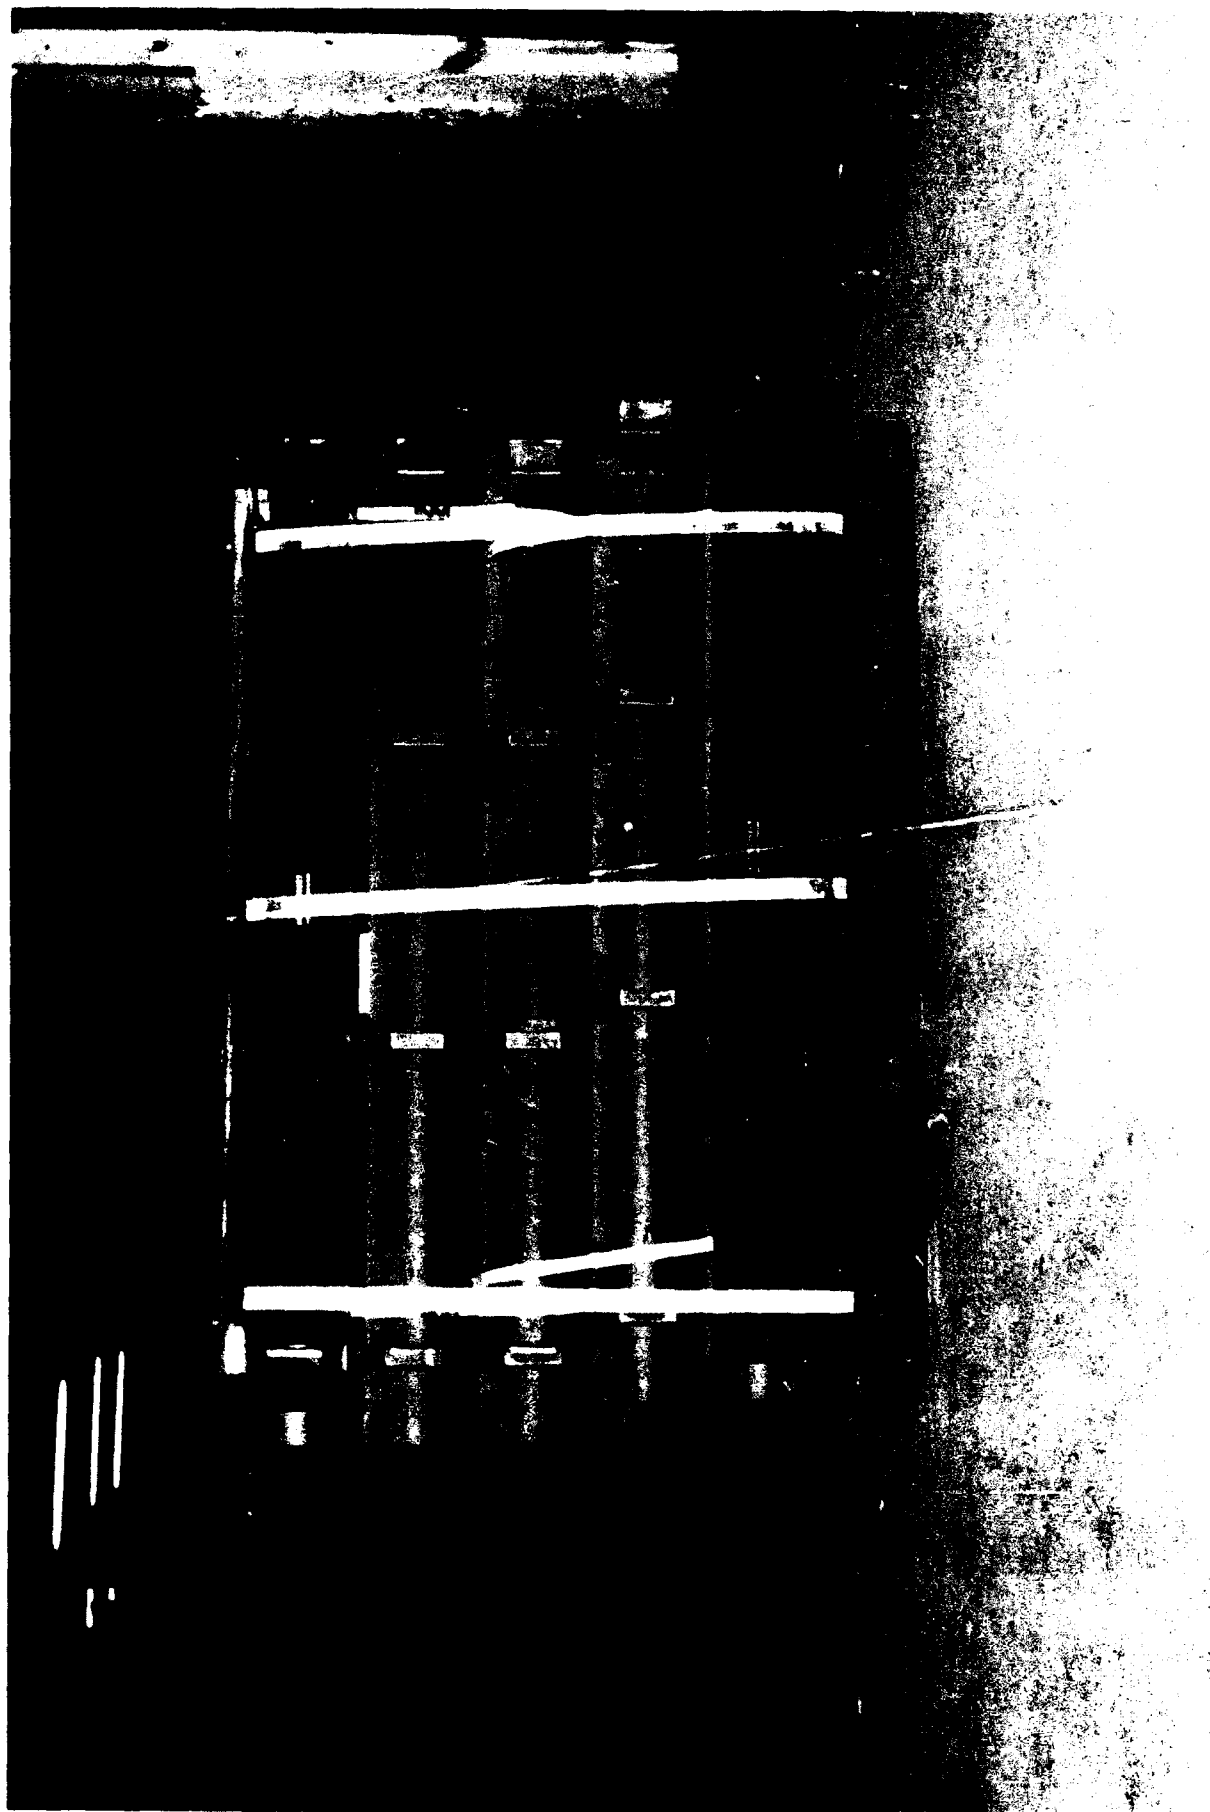
Photo No. AO317-SPN-90-354-5325. This photo shows the deformation of the unitized load following the first iteration of testing.
--

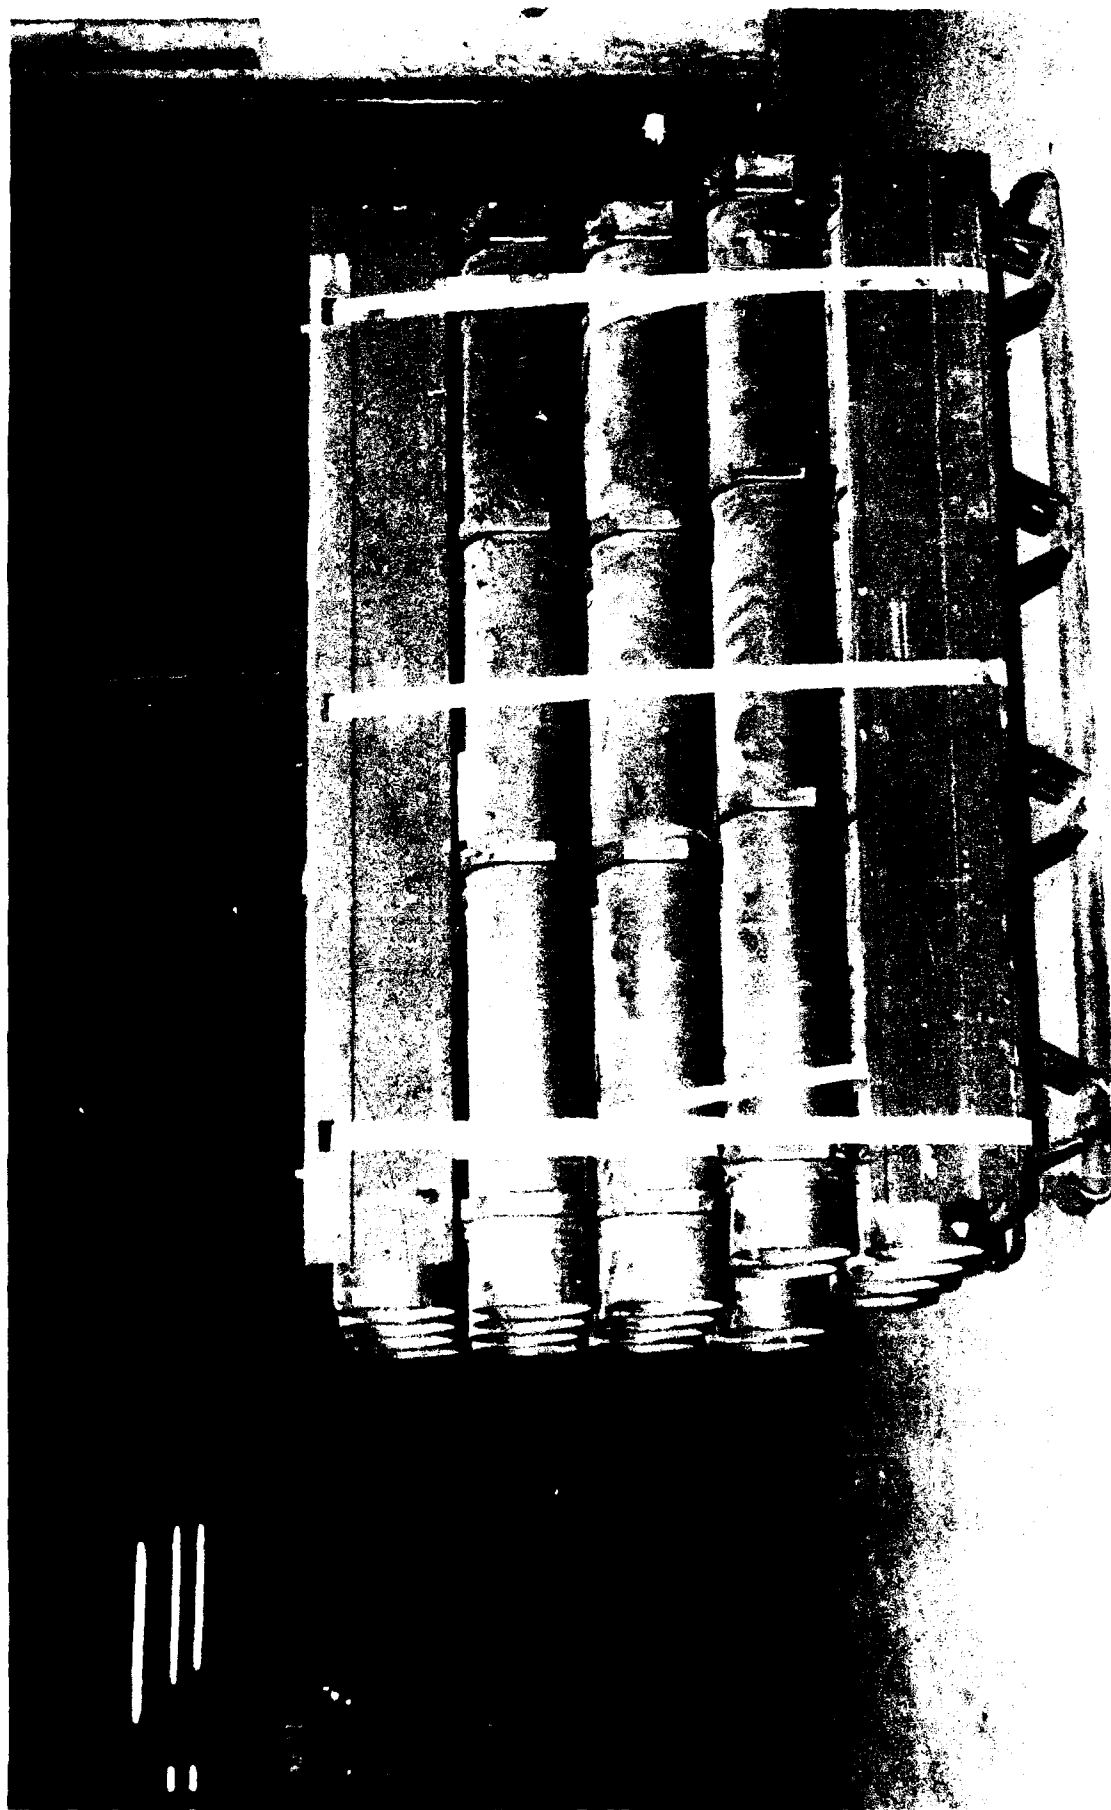
Photo No. AO317-SPN-90-354-5324. This photo shows the deformation of the unitized load following the first iteration of testing.

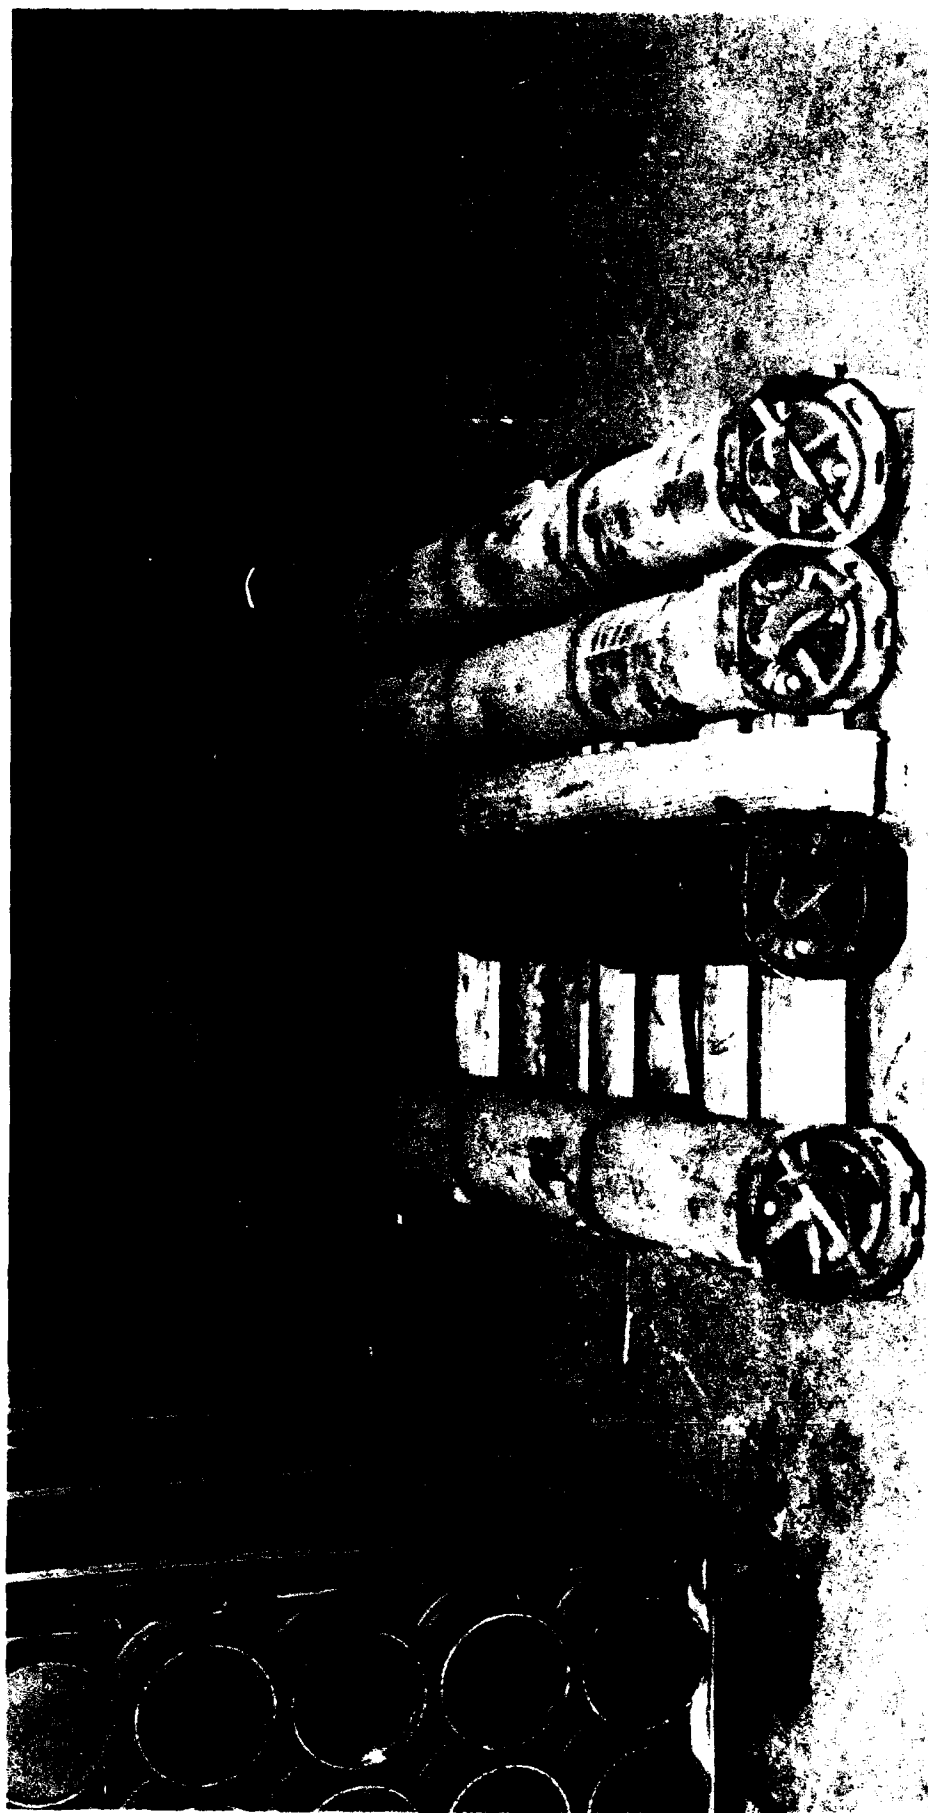
Photo No. AO317-SPN-90-354-5445. This photo shows damage to four Volcano containers following the first iteration of testing. Note the damage to the stacking pins on the bell end of the container and the crushed stacking bell on the opposite end.

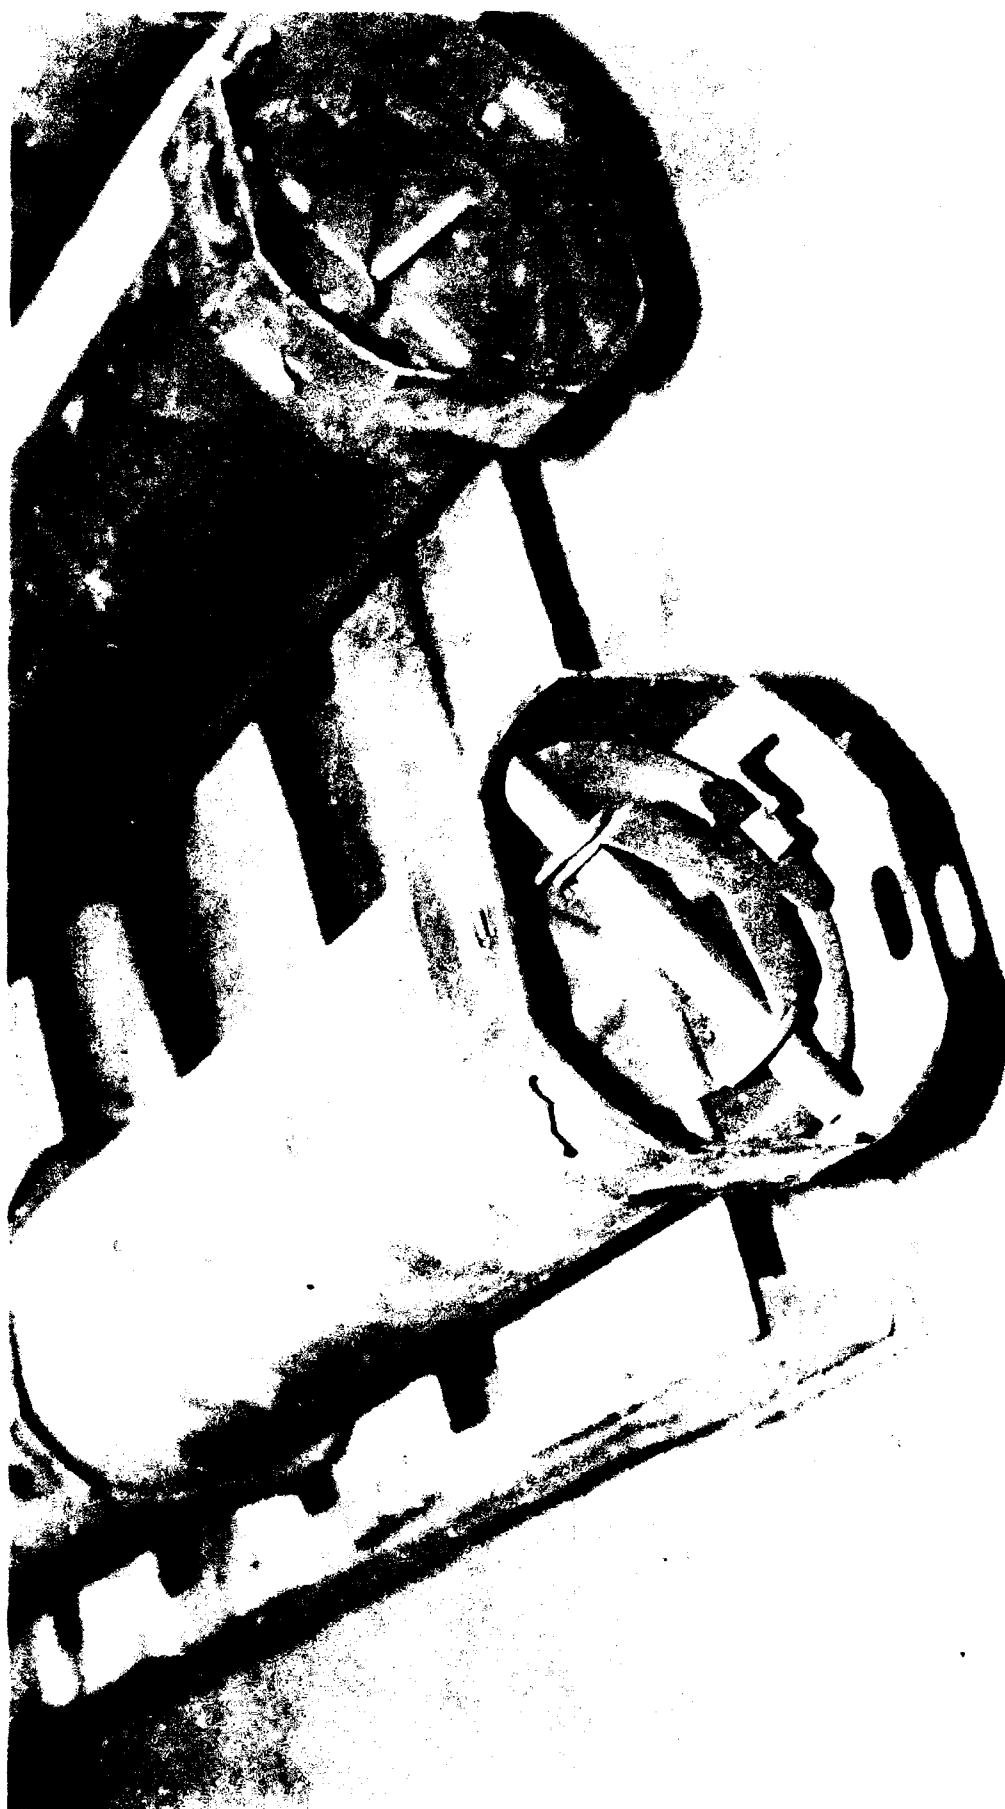
Photo No. AO317-SPN-90-354-5446. This photo shows damage to a Volcano container following the first iteration of testing. Note the removed stacking pin.

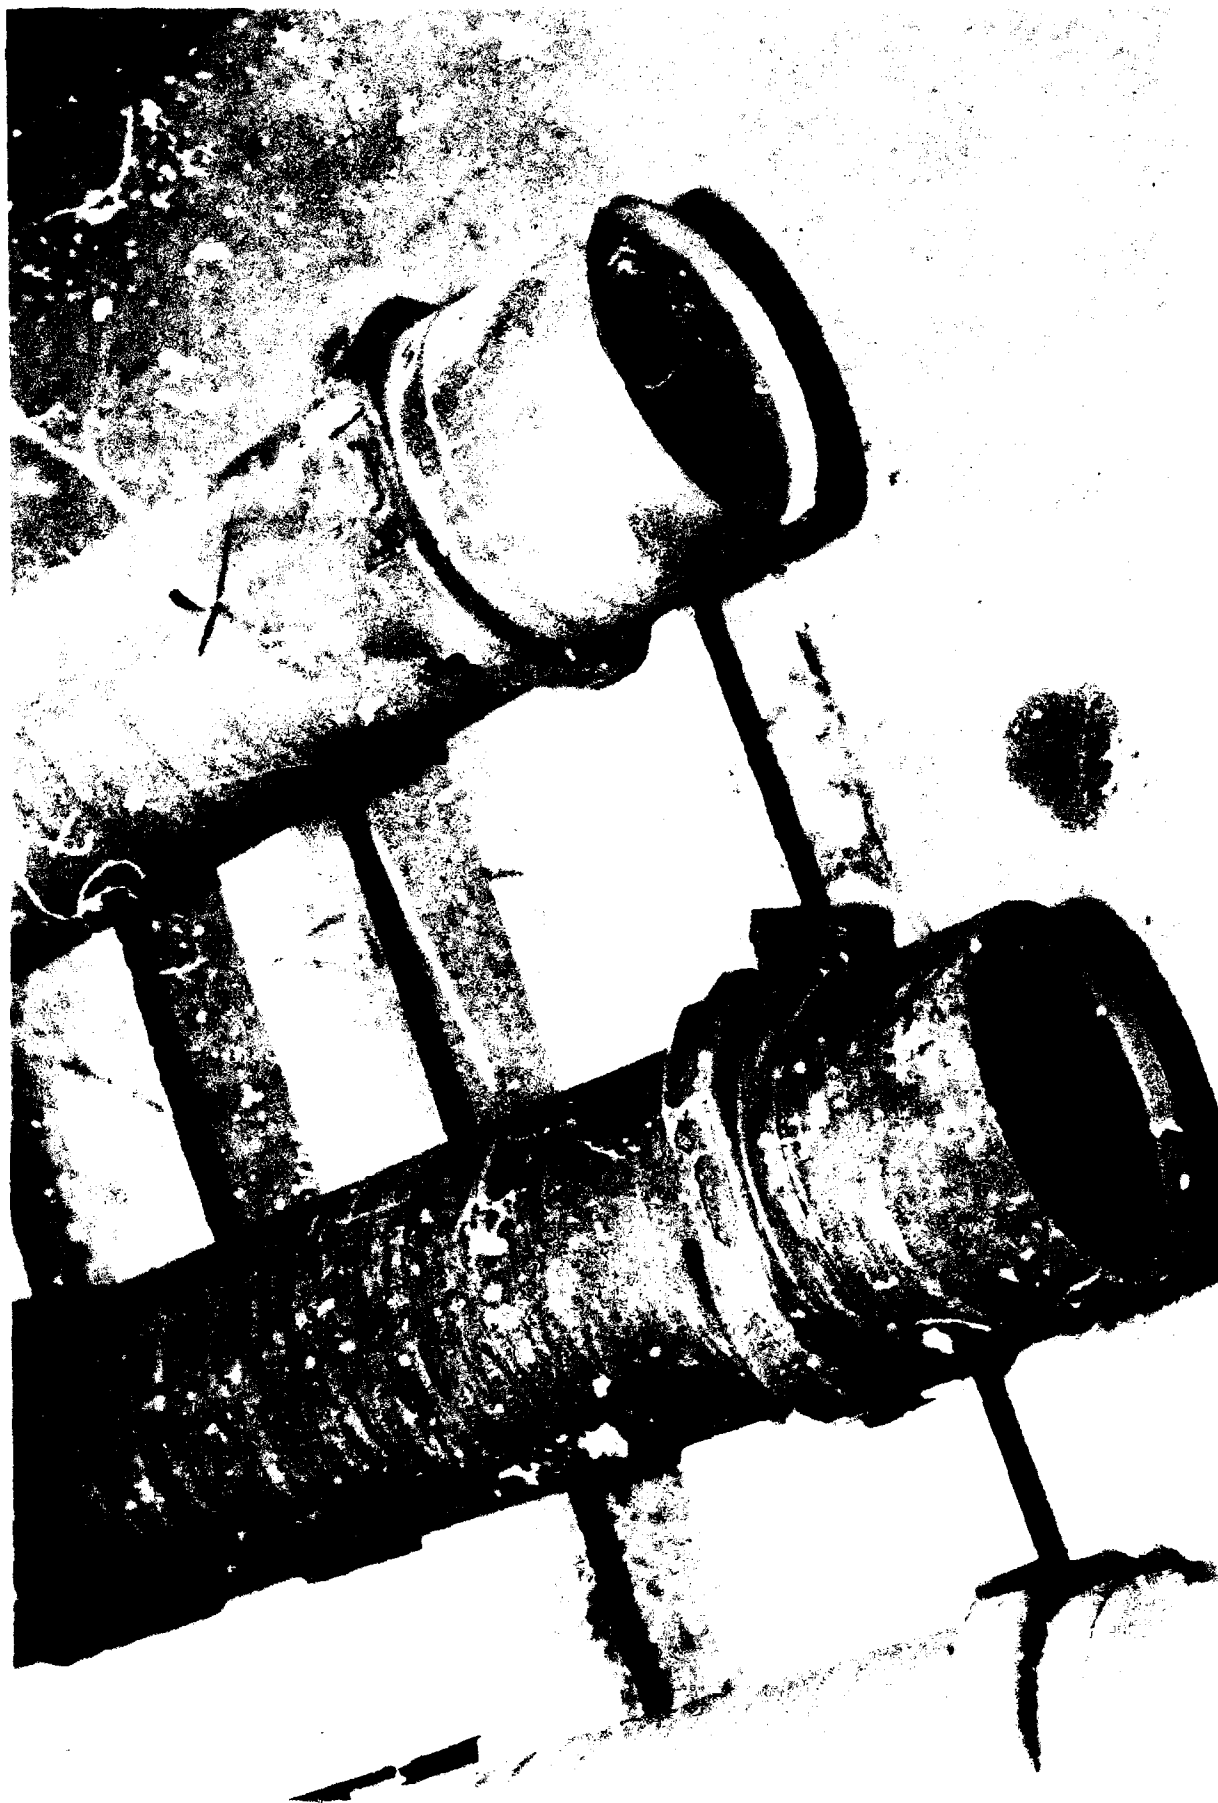
Photo No. AO317-SPN-90-354-5447. This photo shows damage to two Volcano containers following two iterations of testing. Note the crushed stacking bell and damaged lip grips.
